**Analytical Report on the Failure of the [REDACTED] Tanker on [REDACTED].**

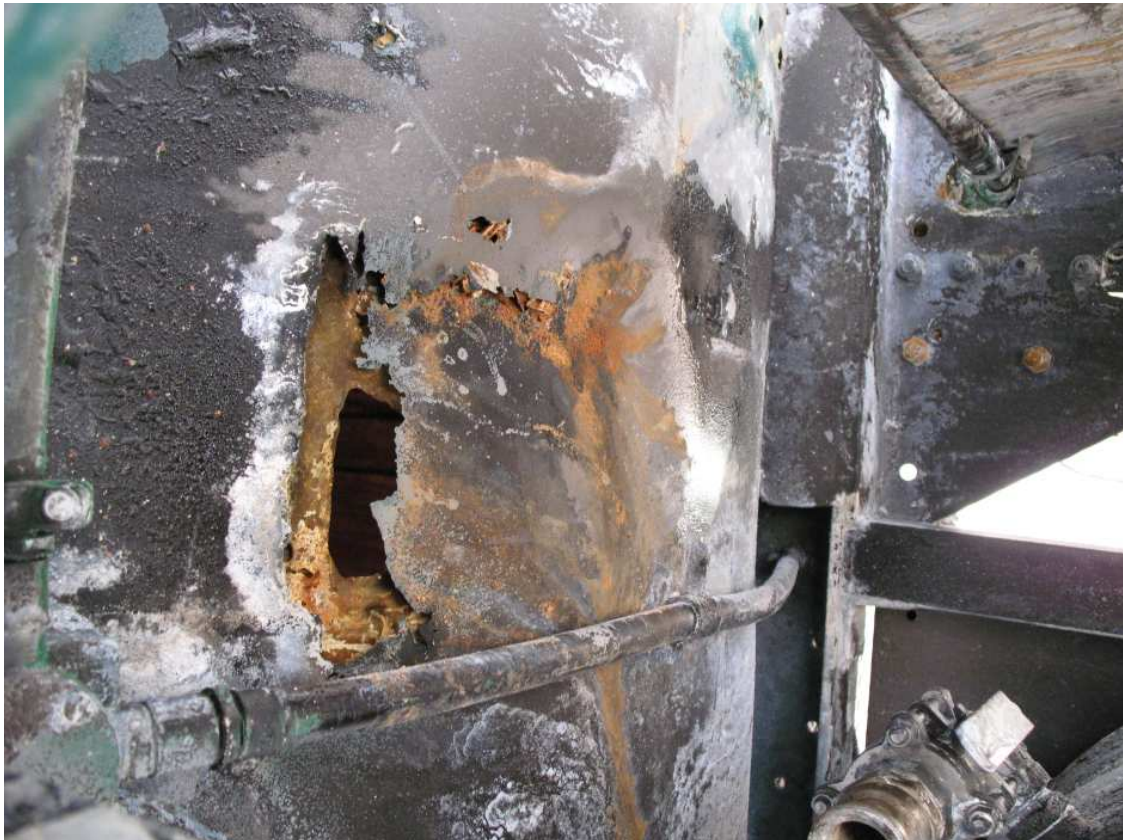
The tanker was of mild steel construction, and had recently been lined with mild steel sheet for extra thickness. The failure occurred by slow corrosion on the underside of the tank, through the liner, then eventually the main body of the tank. The photograph below reveals the nature and eventual extent of the corrosion through both of these layers.

In the present case, sulphur and phosphorus were identified at both the “inner” and “outer” interfaces of the liner material, consistent with the phosphoric acid cargo being carried at the time. However, significantly, zinc was also found on both surfaces.

This element is a marker for [REDACTED] material [REDACTED]. It should be noted here that chloride was not identified in the current analyses, because it would have been lost during the subsequent spill clean-ups, truck wash-down, and the sample removal and preparation procedures. However, the zinc was incorporated in the corrosion products, and its presence suggests that a significant quantity of the chloride was remnant in the tanker at the time of pick-up of the phosphoric-based material.

It is therefore concluded that the chloride had promoted corrosion by interfering with the passivation of the steel. This loss of passivation then allowed the phosphoric acid to corrode the tanker material to failure.
